الحالات الدراسية

الحالة الدراسية الأولى

دراسة تأثير الضرر على أنظمة مساعدة السائق

A8 2018	الطراز	أوودي	نوع المركبة	DA1110201037	رقم الحالة
رمادي	اللون		WAUZZZF86JN012458		رقم الهيكل
وصف الضرر					
أضرار في الجزء الأمامي الأيسر والمقدمة أثناء القيادة نتيجة دخول مركبة من الطريق الرئيسي لطريق الخدمات.

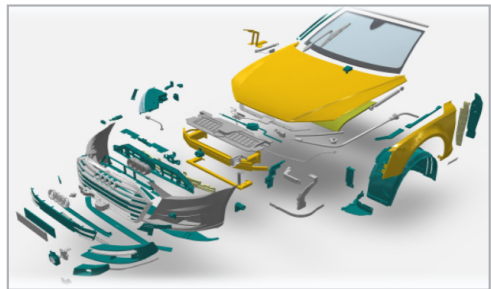
صورة (3)

1. فتح حالة جديدة
2. إدخال كافة البيانات المطلوبة
3. إدخال رقم هيكل المركبة
4. تحديد القطع المتضررة كما في الصورة رقم (3)

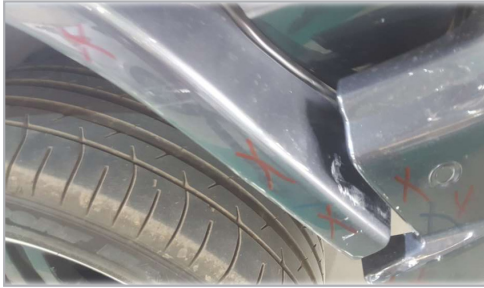
صورة (5)

رقم الحالة	DA190720185	نوع المركبة	مرسيدس	الطراز	جي 63
رقم الهيكل	WDCYC7CF4GX247214	اللون	رصاصي		
وصف الضرر					
أضرار نتيجة تصادم جانبي في الجزء الأمامي الأيمن وأدى صعود المركبة على رصيف الشارع إلى أضرار أسفل المركبة.

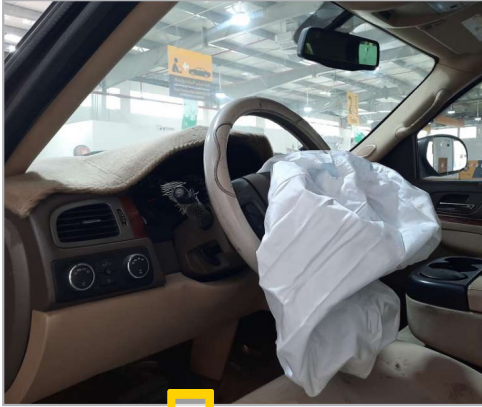
صورة (24)

يوكن	الطراز	G M C	نوع المركبة	DA041020772	رقم الحالة
موكا	اللون		1GKS28E71DR123125		رقم الهيكل
وصف الضرر					
ضرر في الجزء الأمامي الأيمن نتيجة اصطدام في جسم ثابت.

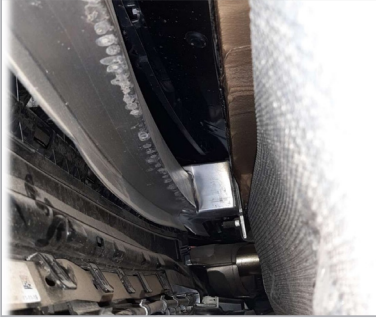
صورة (30)

رقم الحالة	DA0309201878	نوع المركبة	BMW	الطراز	Li 730
رقم الهيكل	WBA7T0A09LCD79667	اللون			
أسود					
وصف الضرر					
ضرر في الصدام الخلفي ومسند رأس السائق
